**DRAFT  
ENVIRONMENTAL SURVEY  
PROPERTY ADJACENT TO OCEANA SALVAGE YARD  
NAVAL AIR STATION OCEANA  
VIRGINIA BEACH, VIRGINIA**

**ABB-ES PROJECT NUMBER: 07739.00**

**Contract No. N62470-95-D-6001  
DELIVERY ORDER 005**

**JANUARY 1997**

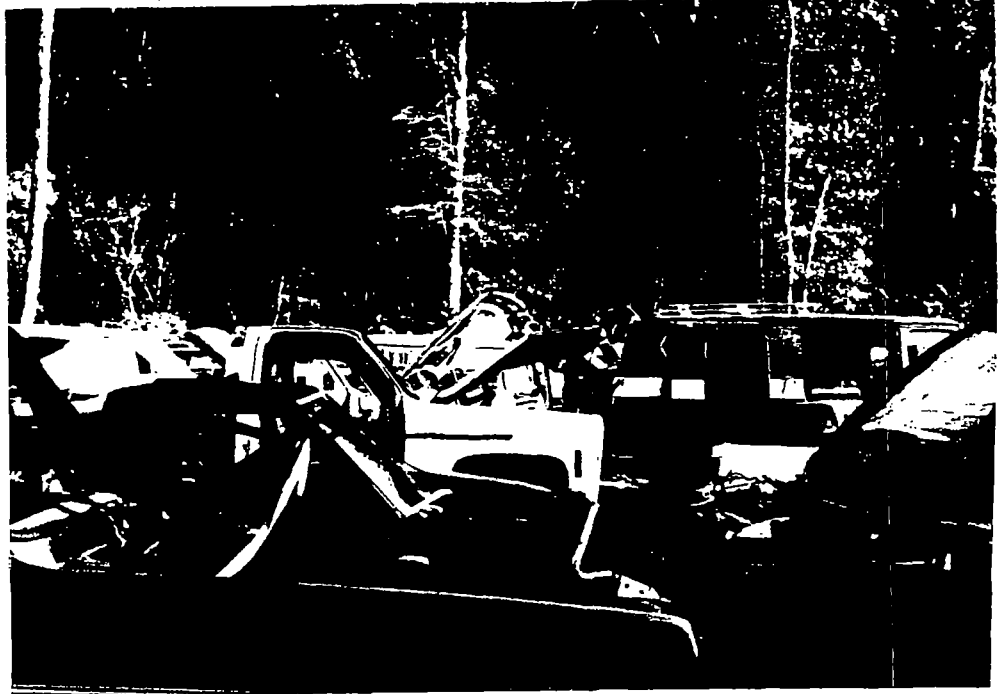
Looking east from the property boundary. Note tire pile in background.

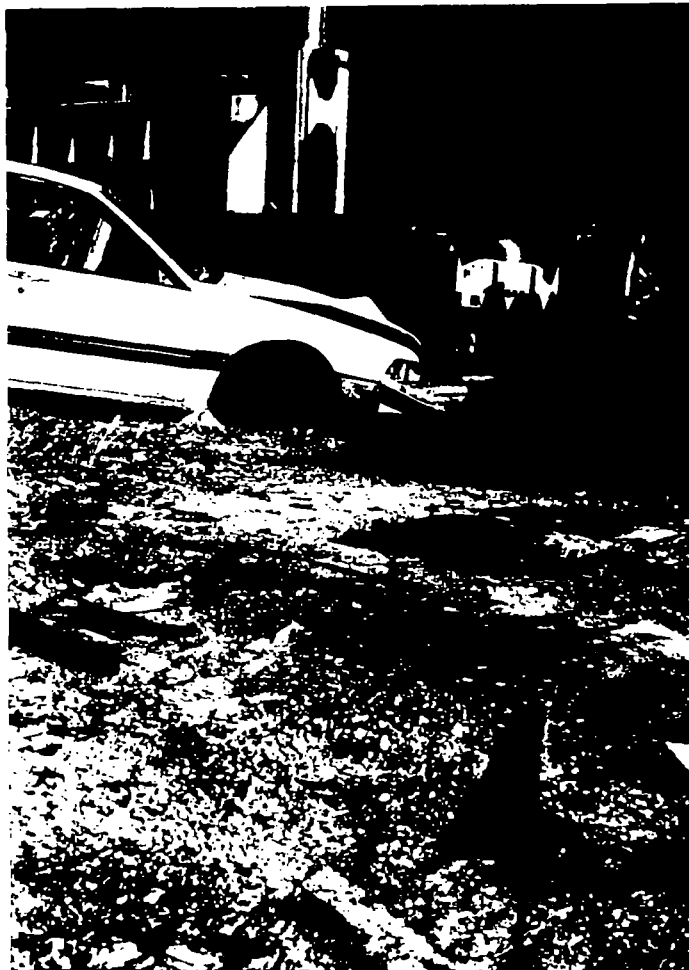
Looking northeast from SS-020 (Lead)  
Car crushing unit in left background.  
Sample location in surface runoff path  
from crusher.

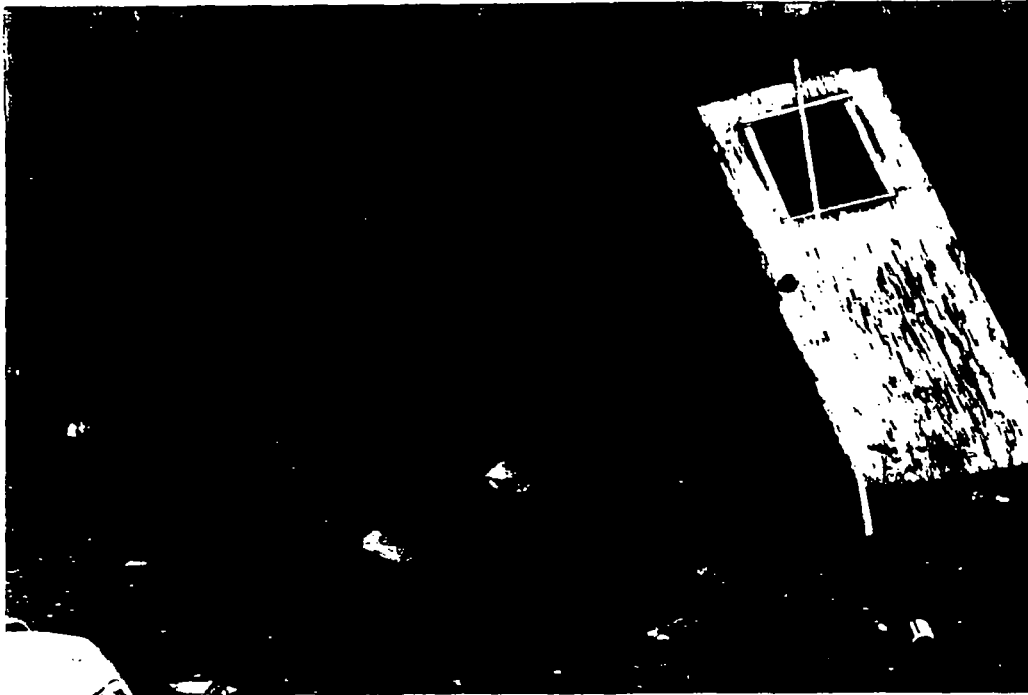
(a) Looking south - SS-001  
(Lead, PCBs, PAHs) Large  
stake marks property line.

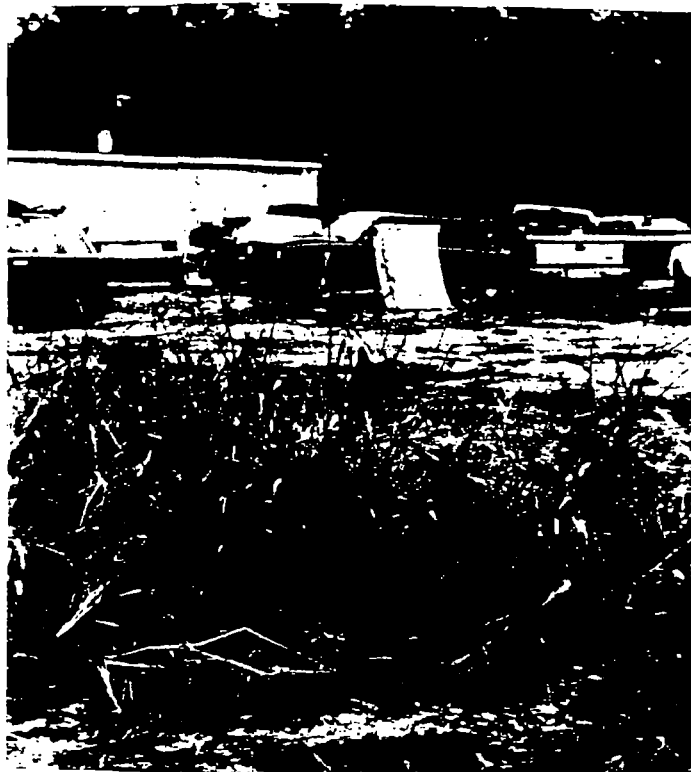
(f) Looking east (salvage yard office in background). Sample location SS-018 (Lead).

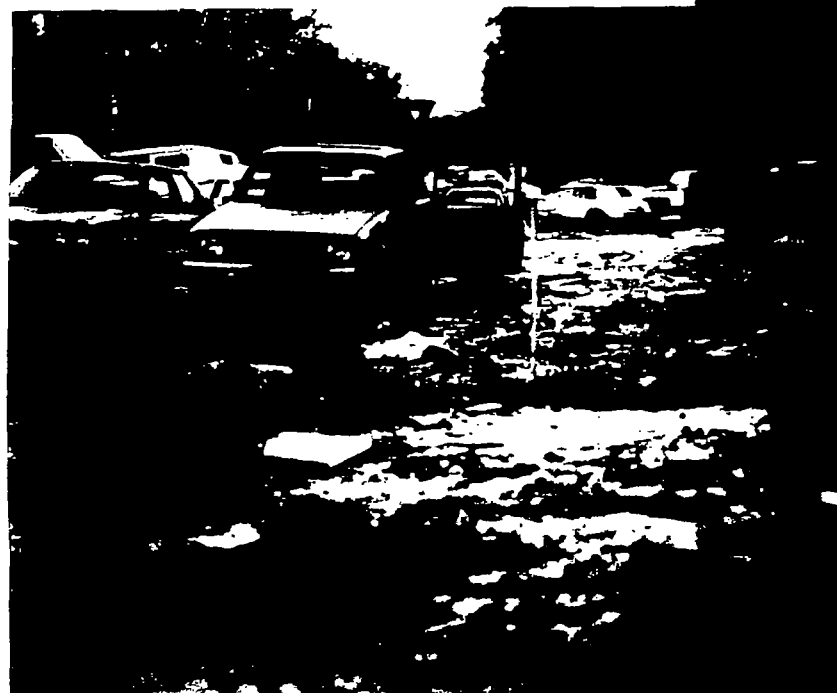
(h) Looking southeast near property line. Sample location SS-019 (Lead)

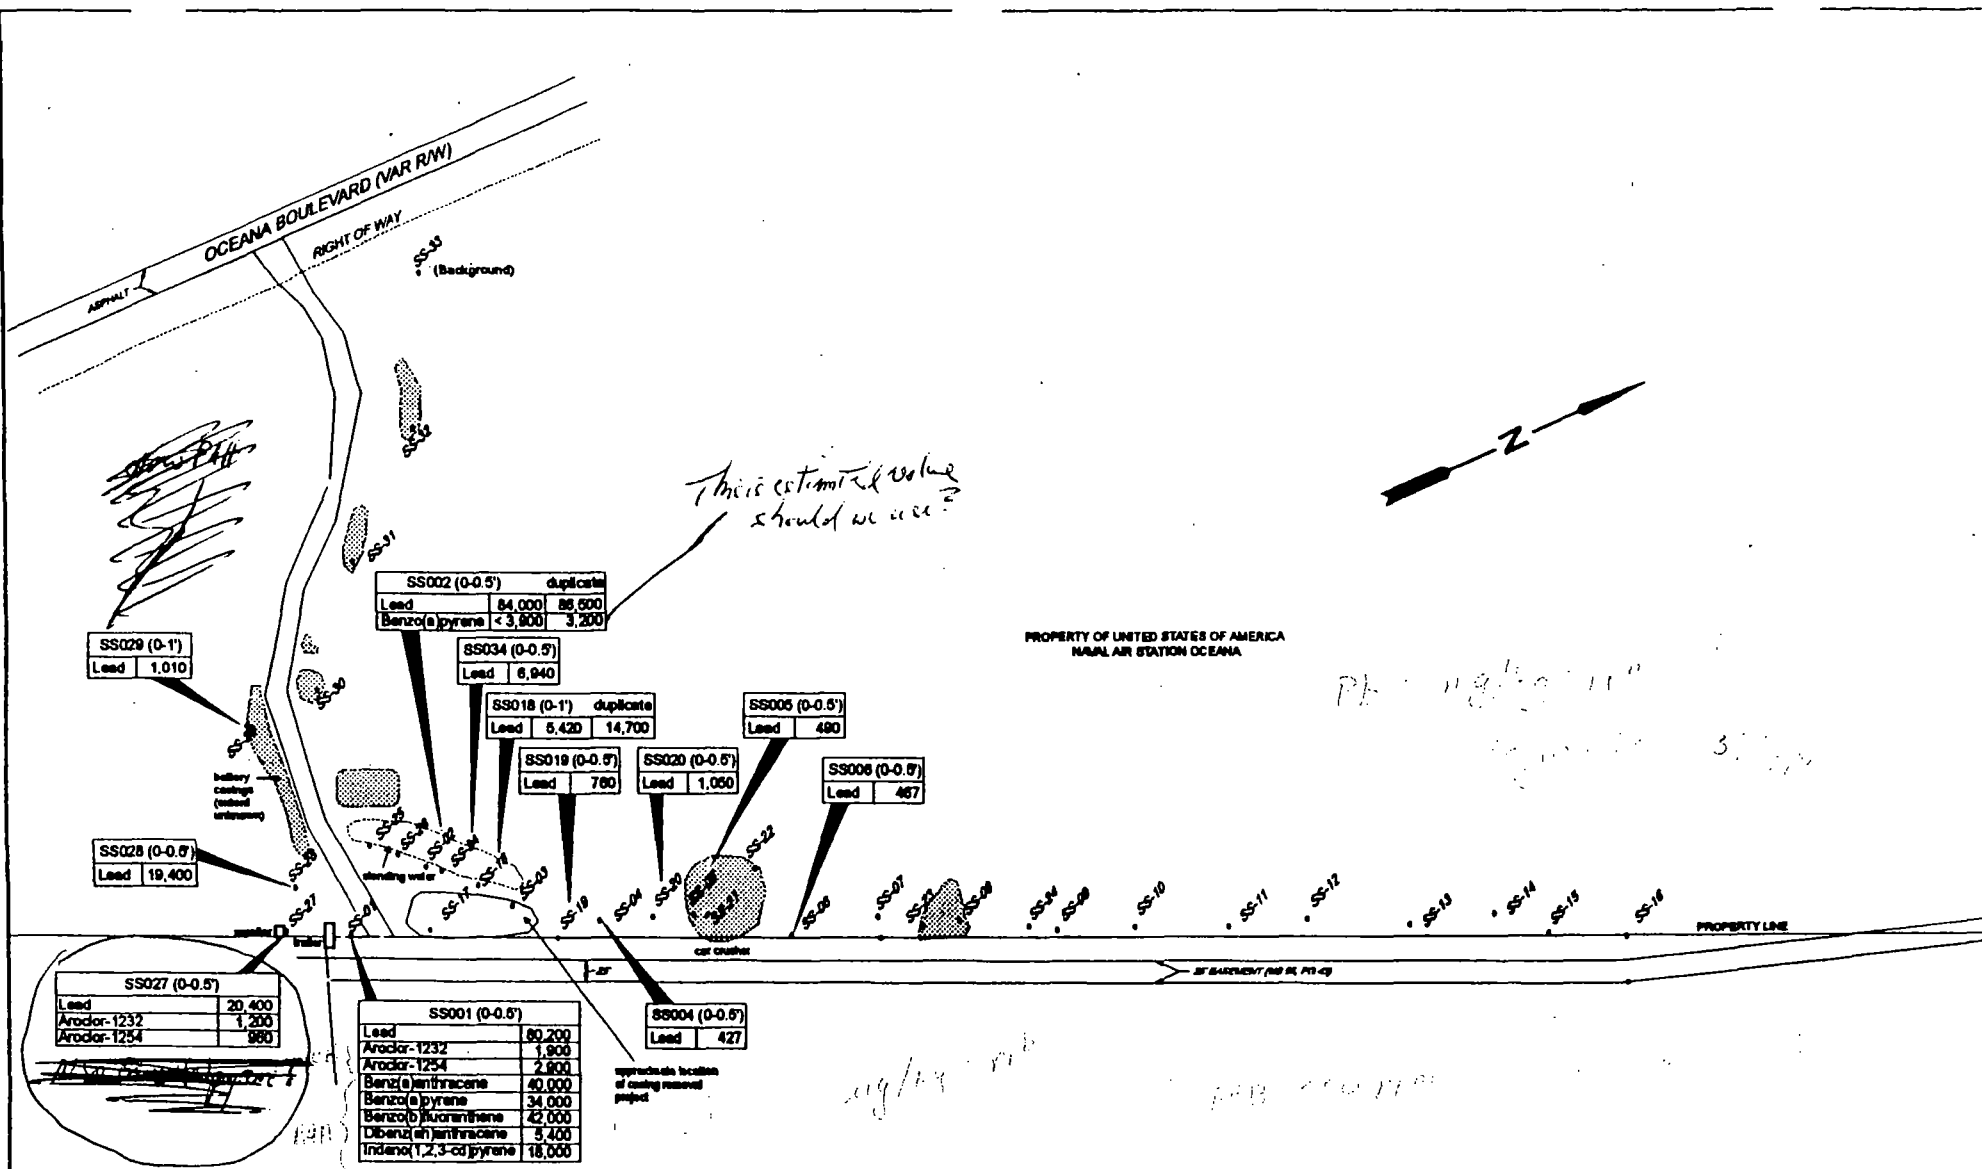
• Areas of significant surface debris • SS-16 Sample location
